Roof Side Weatherstrip - Revised Installation

BO022-00

ROOF SIDE RAIL WEATHERSTRIP POOR RETENTION

'00 Celica

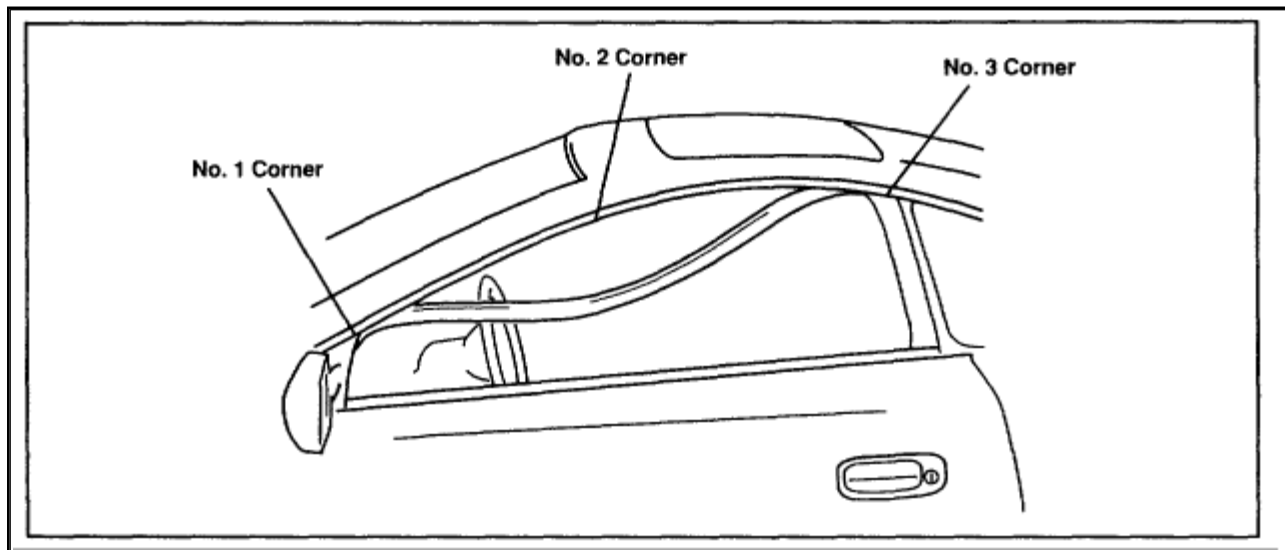
The installation method of the roof side rail weatherstrip has been modified to improve retention between the No. 1 and No. 3 corners on 2000 model year Celica vehicles. The part has not been changed. Use the following installation instructions to reinstall the roof side rail weatherstrip on vehicles with the above concern.
