Outside Door Handle - Loose

BO023R-00

OUTER [DOOR HANDLE](#) LOOSE

'00 Celica

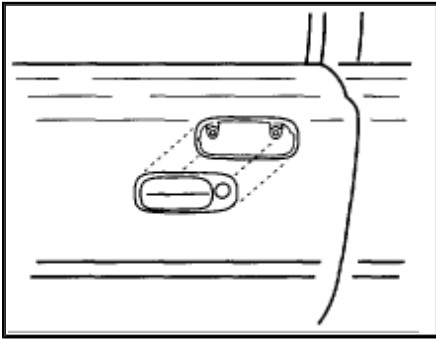
The outer [door handle](#) on some 2000 model year Celica vehicles may appear to be loose due to a gap between the door handle and door panel. A production countermeasure has been implemented. Use the following procedures to reduce outer door handle movement concerns.

1. Remove the door trim panel. (Refer to the 2000 MY Celica Repair Manual, page BO-12.)
2. Peel back the moisture barrier.
3. Disconnect the door lock rod.
4. Disconnect the [door handle](#) rod.
