Automatic Transmission - Fluid Leak
TRANSMISSION & CLUTCH
TC003-00

October 20, 2000

Title:
AUTOMATIC TRANSMISSION FLUID LEAKModels:
'00 Celica GTS

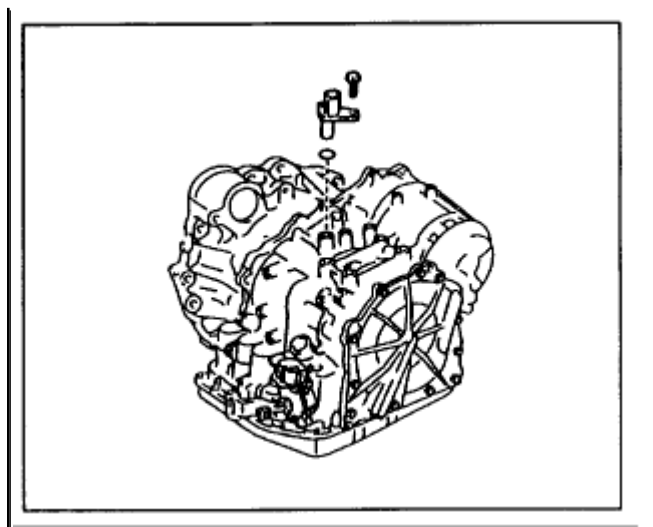
In some cases the U240E transaxle in the 2000 model year Celica GTS may leak automatic transmission fluid from the counter gear speed sensor bolt hole. The repair procedure for this condition is described in this bulletin.

1. Remove the counter gear speed sensor and 'O'-ring.
2. Clean the surfaces of the retaining bolt and the bolt hole.

- A. Blow compressed air into the bolt hole to remove automatic transmission fluid.
 - B. Clean the bolt hole by using a spray cleaner (brake cleaner, etc.) into the hole.
 - C. Clean the bolt threads with a wire brush, then use a spray cleaner to remove debris.
 - D. Repeat the above steps (A through C) 2 to 3 times.
3. Install the speed sensor.
